Appendix B – Photographs of Cross-Sections and Estimated Manning's n

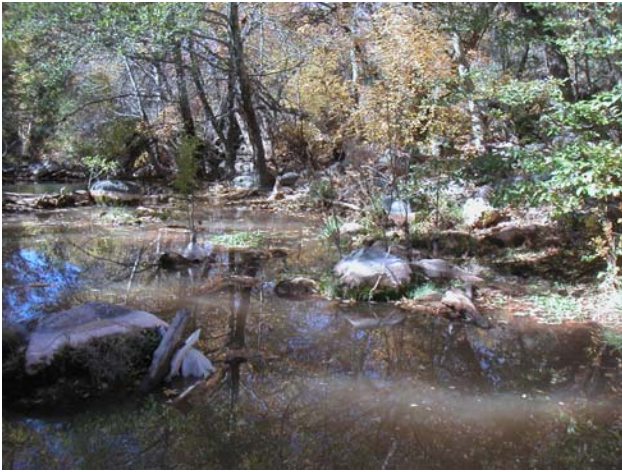
Looking downstream near Sta: 0+00, downstream boundary condition: Channel sluggish reach – pools (n= 0.07): Floodplain on Left medium vegetation large cobble (n=0.11): Travertine Dam in Background

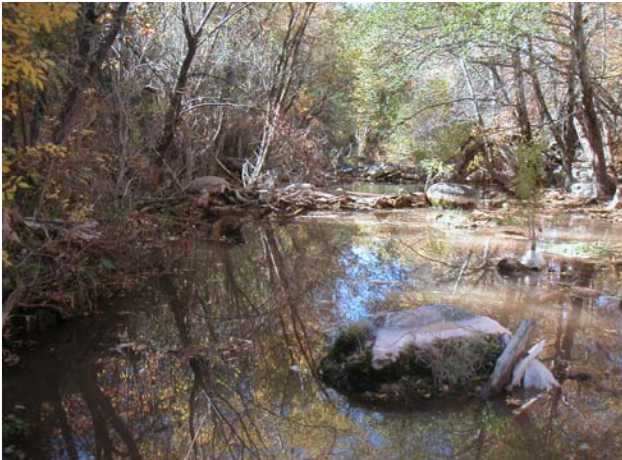
Looking Downstream near STA: 0+00, Downstream Boundary Condition: Channel sluggish-pools (n= 0.07): Floodplain on left (n=0.11): Floodplain on Right (n=0.11): Travertine Dam in Background

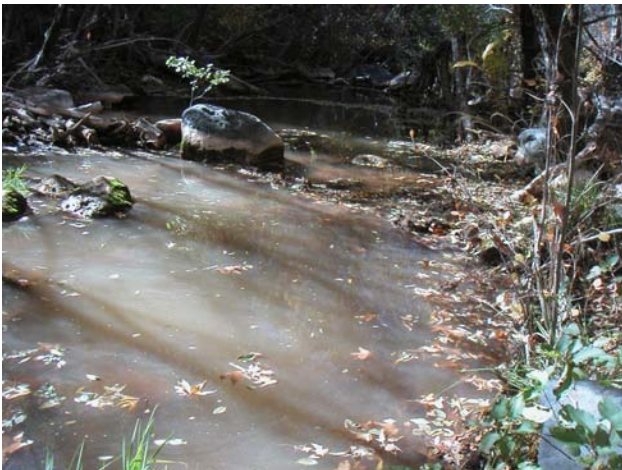
Travertine dam in background and impounded water near Sta: 0+50. Channel sluggish-pools (n= 0.07)

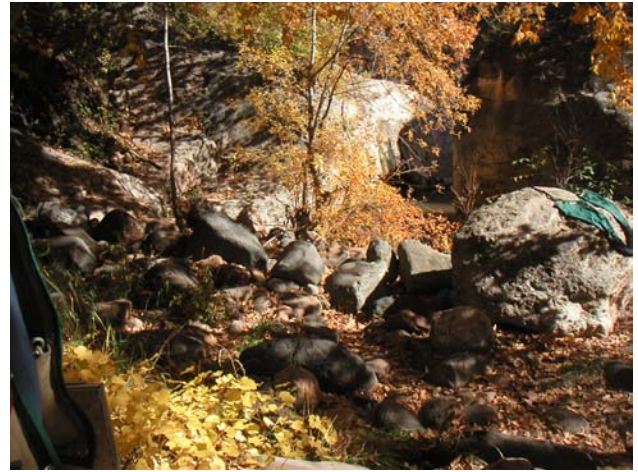
Looking upstream near Control Point #2 Sta: 1+15, Floodplain medium brush and trees with cobbles and boulders (n=0.11)

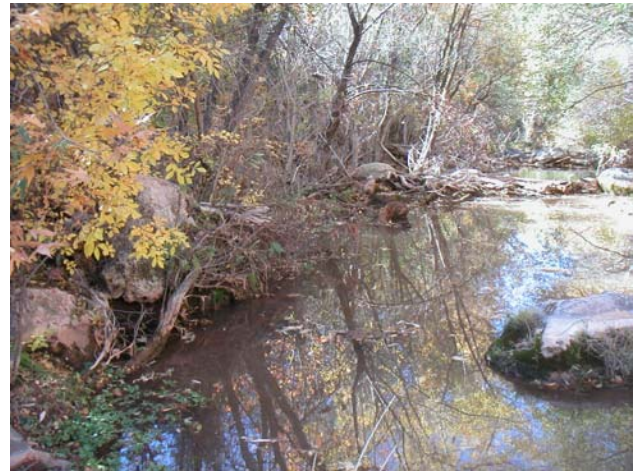
Looking Downstream near STA: 0+00, Downstream Boundary Condition: Channel sluggish-pools (n= 0.07): Floodplain on left (n=0.1): Floodplain on Right (n=0.11): Travertine Dam in Background

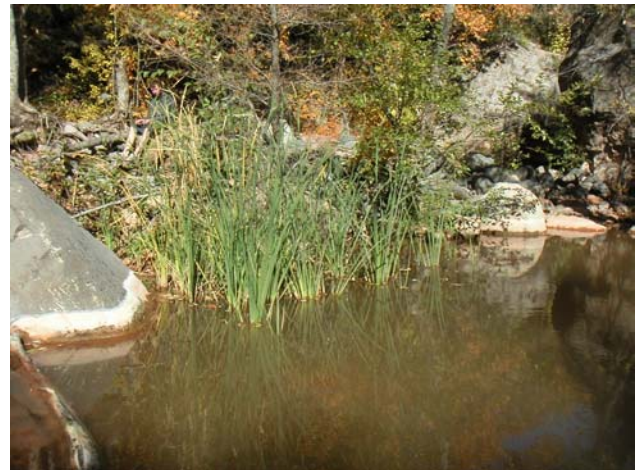
River right bank condition Sta: 1+00, the rock on the left is shown on the topography. Channel sluggish pools (n= 0.07): floodplain (n=0.11)

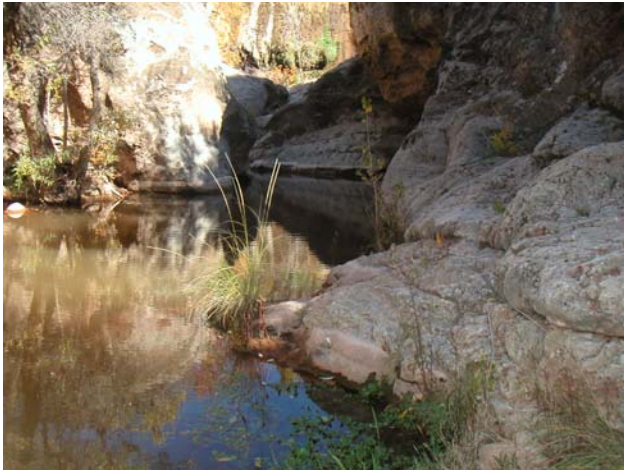
Looking upstream near Sta: 0+75: Channel cobble bottom-clean sides (n=0.05): Rock outcrop on river right clean –sides-irregular (n=0.05):

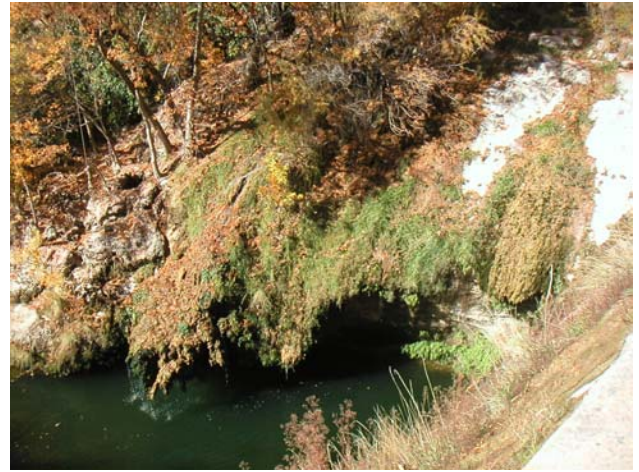
Looking downstream from the top of dam Sta: 2+95. Channel and bedrock (n=0.05)

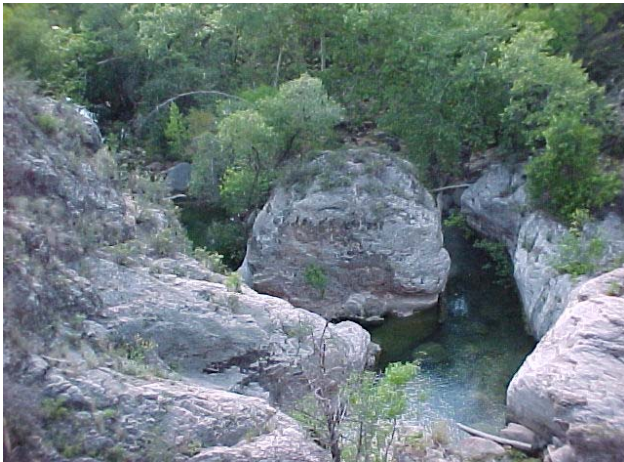
Looking at approximate Sta: 2+25. Channel and bedrock banks cobble bottom-clean sides-irregular (n=0.05)

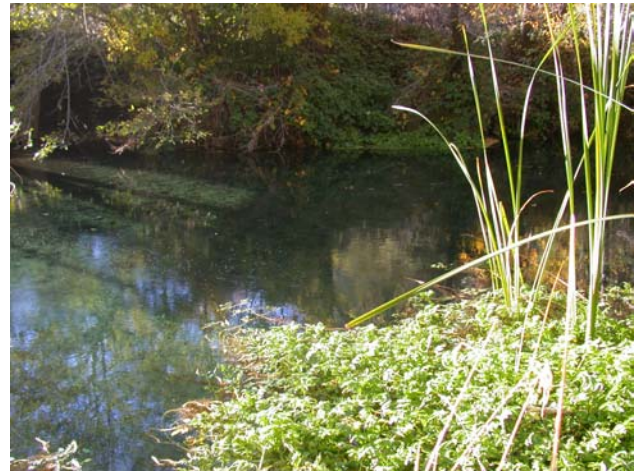
Pool located at Cross-Section #1 Sta: 4+00. Weedy-sluggish (n=0.065)

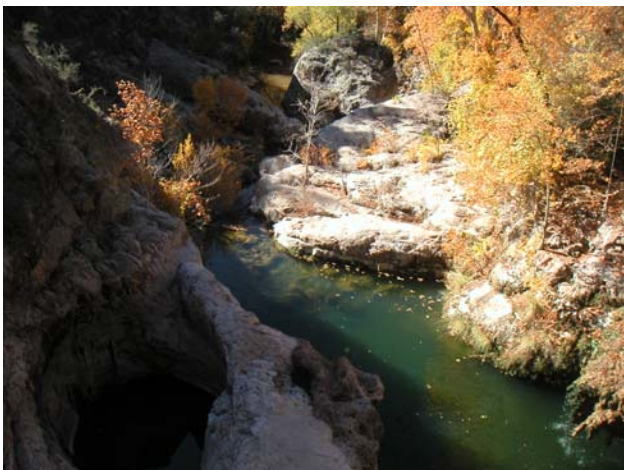
Looking downstream from the top of dam Sta: 2+95. Channel and bedrock, cobble bottom-clean sides-irregular (n=0.05)

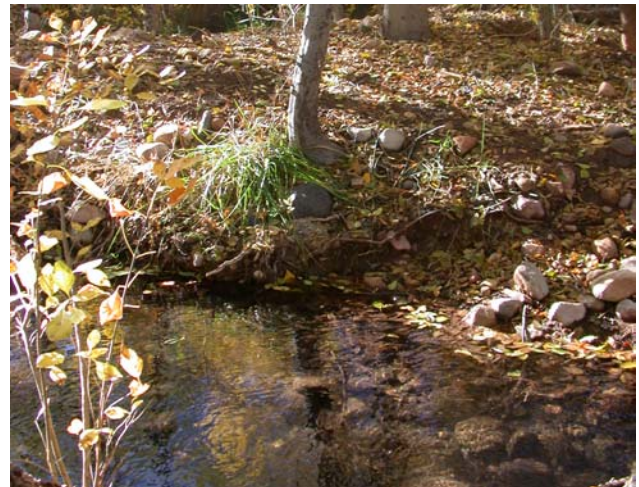
Typical Channel and bank conditions near Cross-Section #2 Sta: 5+50. Channel (n=0.055): Floodplain medium brush with trees (n=0.085)

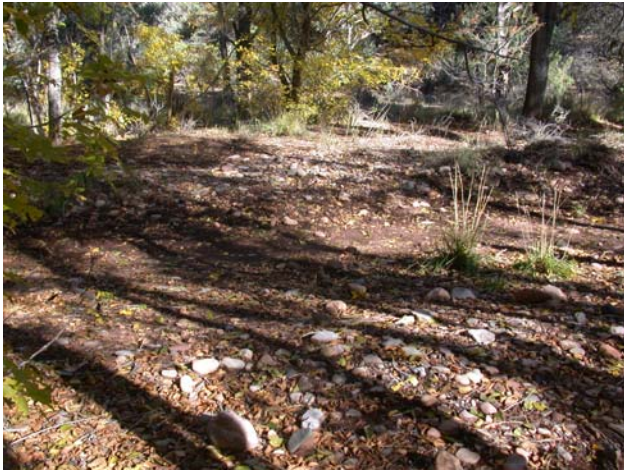
River Right Floodplain Condition at Cross-Section #2
Sta: 5+50. Floodplain ($n=0.085$)

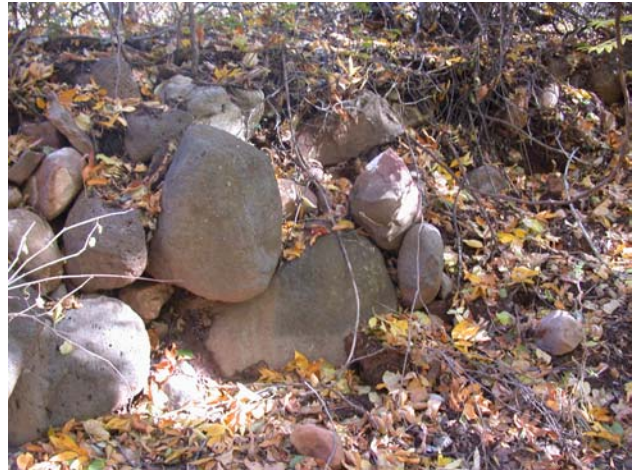
Scoured Area at Cross-Section #4. Sta: 9+25

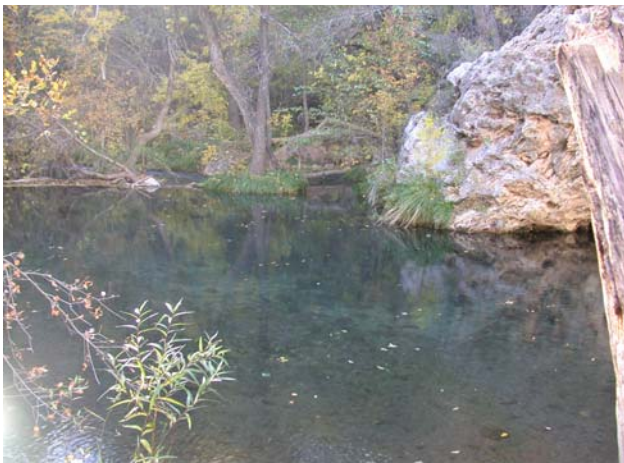
Pool located at Cross-Section #3 Sta: 8+25, Photo is
taken from river left bank. Channel ($n=0.06$)

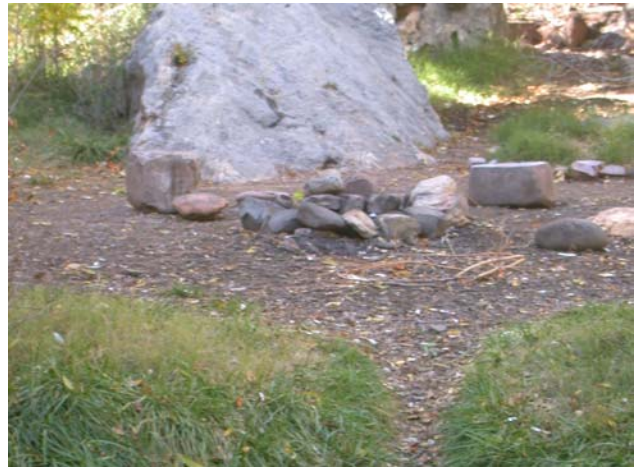
Floodplain Condition and material at Cross-Section #4
Sta: 9+25. Floodplain ($n=0.085$)

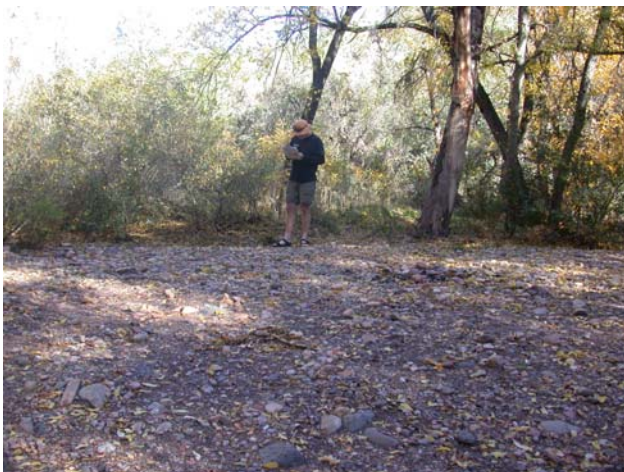
River Right Floodplain at Cross-Section #3 Sta: 8+25.
This photo shows the large point-bar deposit across
from the large rock. ($n=0.085$)

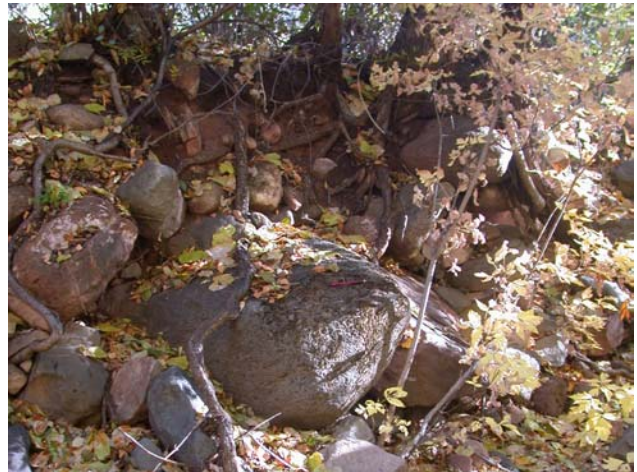
Typical Channel bank conditions near Cross-Section
#5 Sta: 10+00

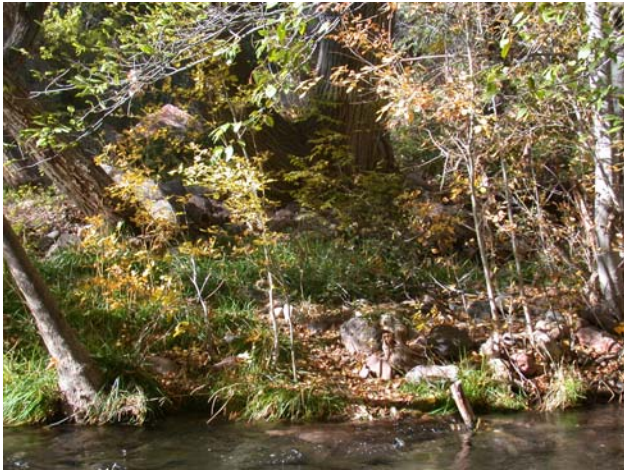
River Right Channel and Bank Condition at Cross-Section #5 Sta: 10+00. Channel ($n=0.055$): Floodplain ($n=0.1$)

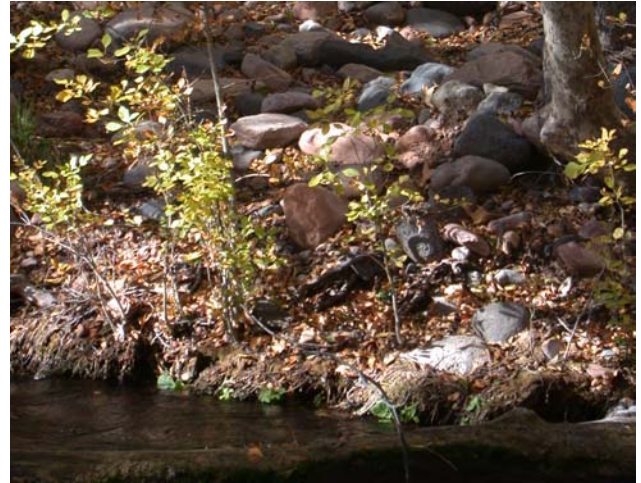
Bank Condition at Cross-Section #6 Sta: 10+60

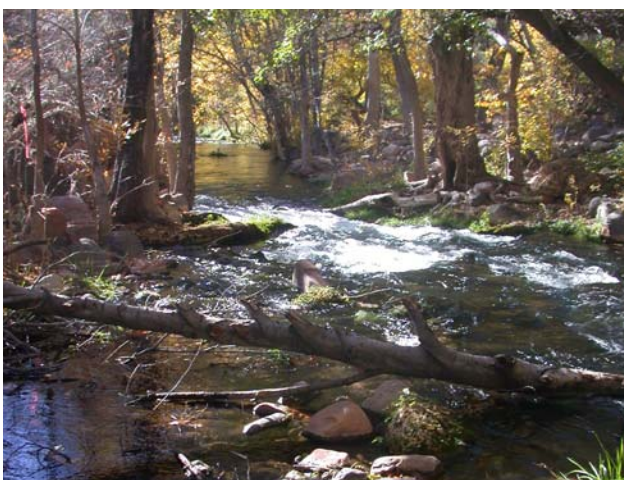
Looking Downstream from Cross-Section #6 through riffle to pool Sta: 10+60. Channel ($n=0.065$): Floodplain river left and river right ($n=0.1$)

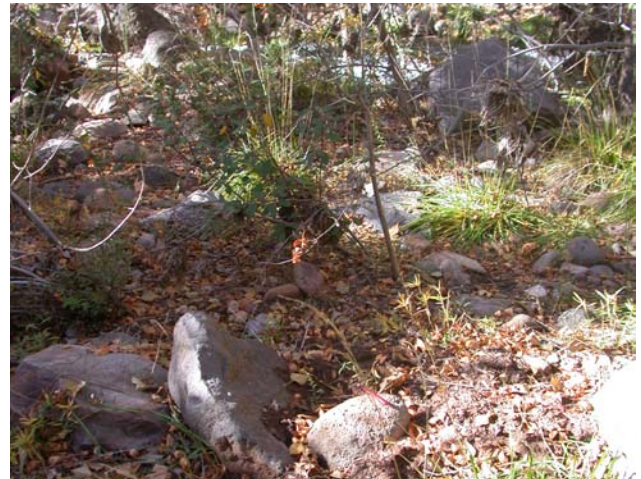
Floodplain Condition and material at Cross-Section #6 Sta: 10+60. Floodplain ($n=0.1$)

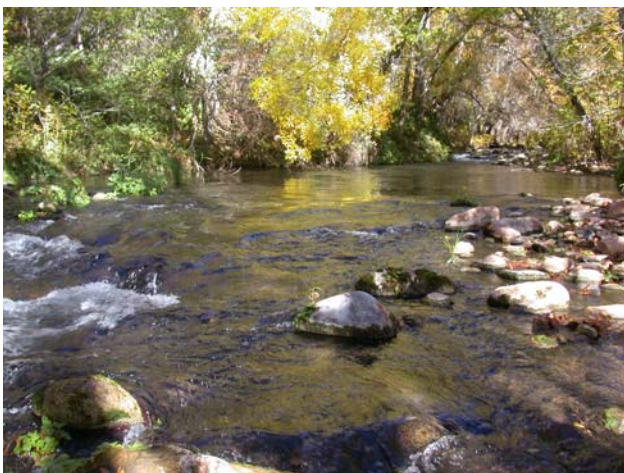
Looking Upstream from Cross-Section #6 Sta: 10+60 Channel through riffle to upstream pool ($n=0.065$)

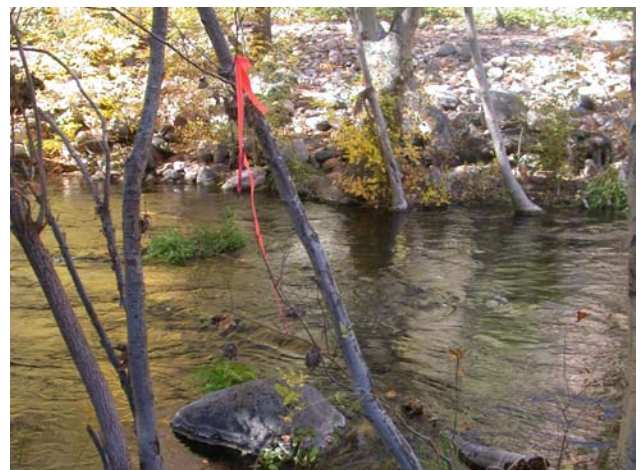
Looking across channel to River Right Bank at Cross-Section #6 Sta: 10+60. Channel ($n=0.065$)

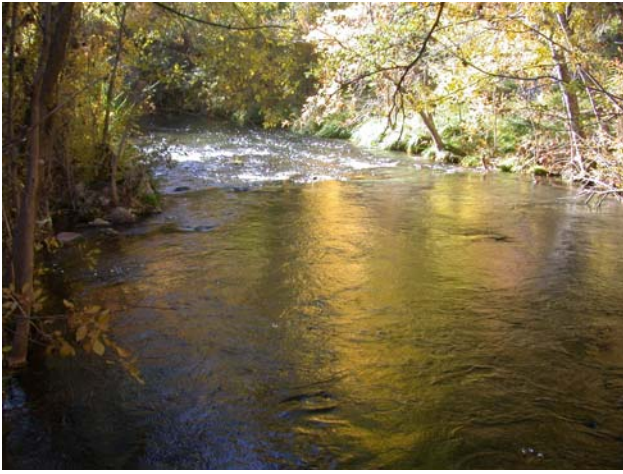
Looking Downstream from Cross-Section #9 through pool to riffle. Sta: 12+50. Channel ($n=0.06$): Floodplain ($n=0.1$)

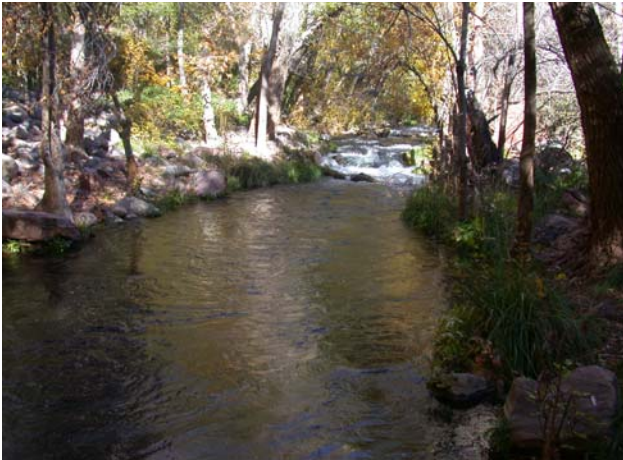
Looking Upstream from Cross-Section through pool to riffle. #9 Sta: 12+50. Channel ($n=0.06$): Floodplain ($n=0.1$)
