Fossil Creek Native Fish Restoration Project

Final Project Report, November, 2005

Federal Aid in Sportfish
Restoration, Project F-7-M

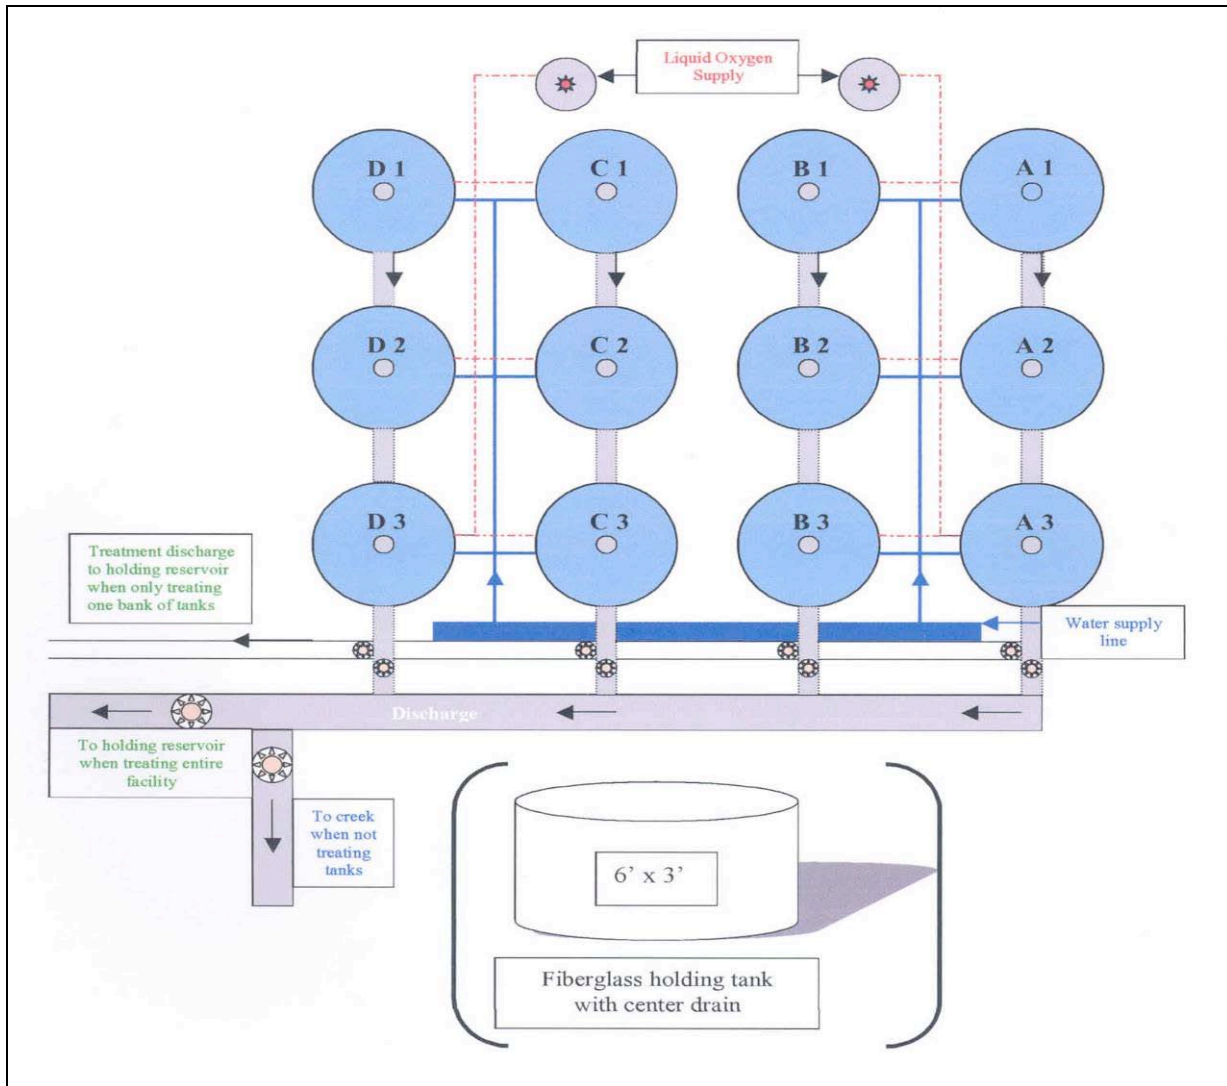
Figure 3. Fossil Creek native fish holding facility design. The facility was constructed at Irving prior to project implementation.

The holding facility consisted of twelve circular raceways, independently plumbed and provided with available auxiliary oxygen supply, if needed (Figure 2). A continuous flow of water was provided via a 2-inch high pressure (~240 psi) line fed directly from the penstock of the Irving hydroelectric turbine. Water pressure was lowered via a pressure reduction valve to about 80 psi and plumbed through 1.5 inch PVC pipes to each raceway. Outflow from the raceways was directed via 2-inch lines to a dirt holding basin or to the creek.

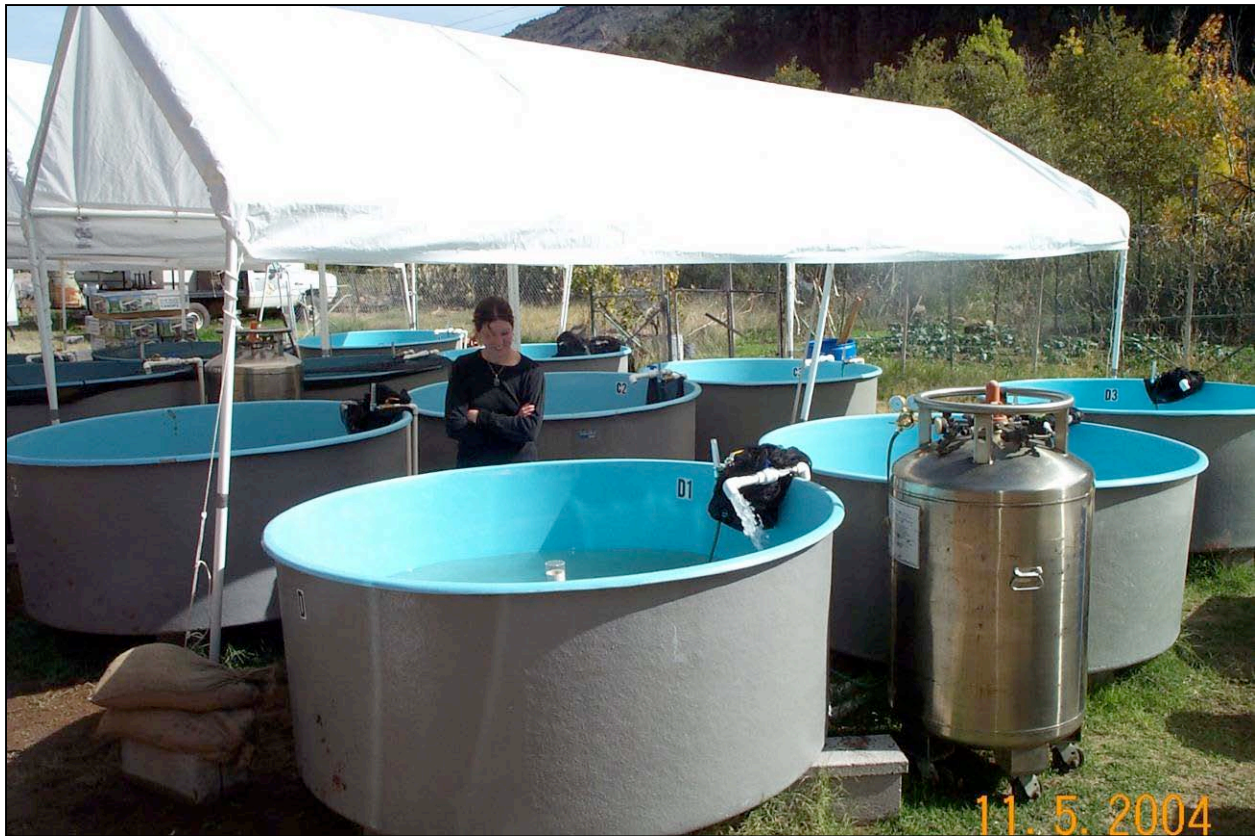
Figure 4. Fossil Creek holding facility as constructed at Irving, Az during Fall 2004.

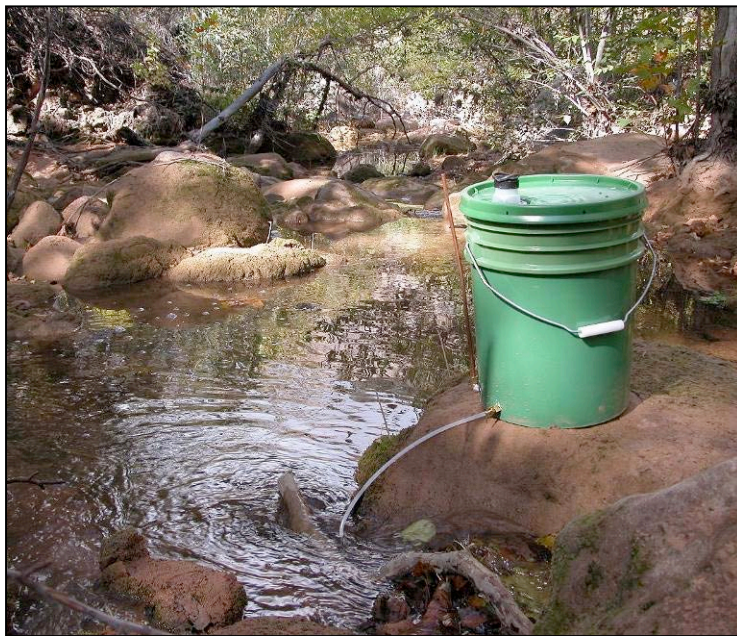
Figure 5. Drip bucket in operation showing typical stream channel placement.

In July and September, Reaches 1-2 and 3-4 (respectively) were measured and mapped by walking each reach with a hip chain in a downstream direction and flagging points every 150 m to determine drip station placement. Each drip station was shifted upstream or downstream to the nearest suitable single channel with good flow, or if it fell within a large pool. Distance measurement began again from that point. UTM's of bucket locations were recorded with a Garmin 12 GPS, with point localities averaged to get about a +/- 15-foot accuracy. Bucket points and heads of each pool measured were then mapped using Arcview 3.2 (Figures 3-6). Drip station placement is recommended at approximately 150 m intervals to re-charge stream

concentration as dilution, biodegradation and oxidation of Antimycin occurs during travel downstream.

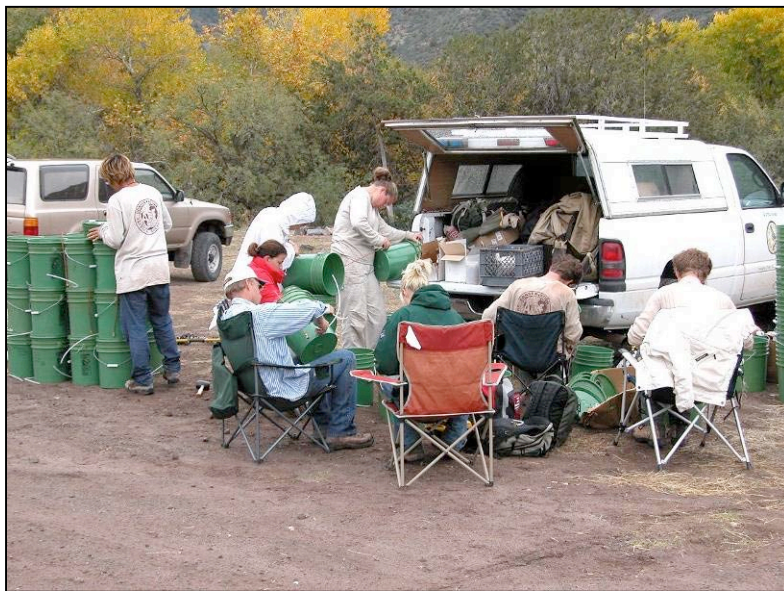
Figure 9. Fossil Creek Native Fish Restoration crews assisting with assembly of drip buckets for placement along the stream.

On November 10, Reach 4 was treated for the first time. The formulation was prepared and placed in 4 L nalgene bottles on the evening of November 9 for transportation and distribution by

the field crews at an expected discharge of 12 cfs. However, discharge measurements made on the morning of November 10 showed discharge to be at 11 cfs. Again it was too late to modify the 4 L containers that the crews were using to transport the formulation into the field to the drip buckets, so the stream was treated with the same amount of Fintrol, 2440 ml. This resulted in a first treatment of Reach 4 at 54 ppb Fintrol. We again conducted backpack spraying and sand application to pools as previously described.

buckets located in side-channel habitats receiving partial charges. At the recommendation of the Fintrol manufacturer, additional surfactant, Non-oxynal 9, was added at a ratio of 65ml/480 ml Fintrol. Thus each crew was given a 125 ml nalgene container with 102 ml of Fintrol and 14 ml surfactant for a fully charged bucket, less for partial charging.

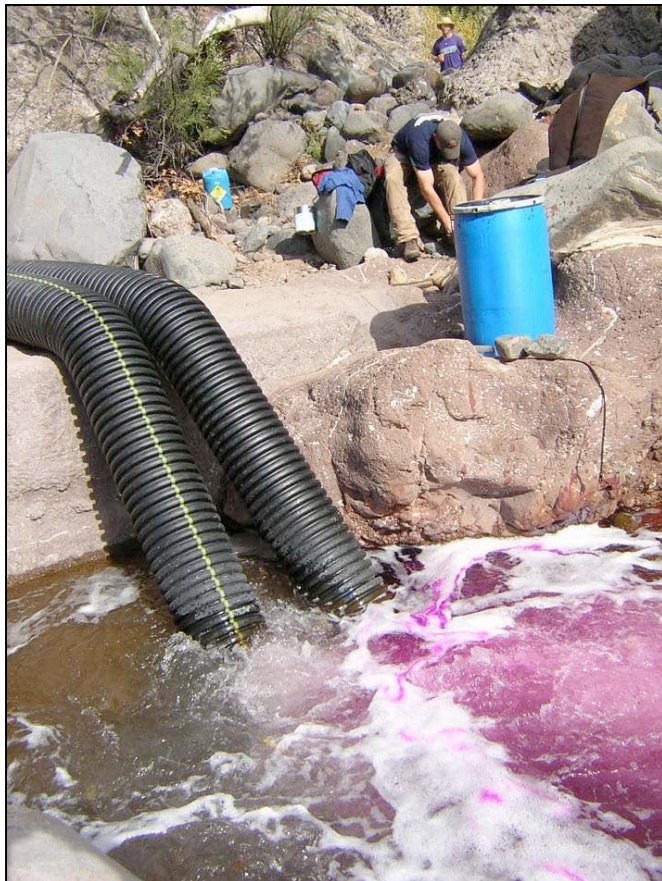
Figure 10. Fossil Creek Native Fish renovation, neutralization station at downstream end of targeted reach, Fossil Creek Fish Barrier.

A neutralization station was established at the downstream end of Reach 4, at the newly constructed fish barrier. Liquid sodium permanganate was used as the oxidizing agent instead of powdered potassium permanganate because of previously stated properties. This allowed the two-man crew operating the neutralization station to apply the permanganate at a reduced rate. If 2.5% permanganate had been used, flow from the drum would have to be 2520 ml/min at the measured stream discharge of 12 cfs. This would have effectively drained the drum in 45 minutes and required around the clock mixing and re-filling the drum. Using the liquid permanganate allowed for a dispensing rate of 289 ml/min, the rate at which it was actually applied, to reach a concentration of 3 ppm permanganate in the stream at a discharge of 11 cfs.

Neutralization of the piscicide at the downstream end of the targeted reach involved application of 605 L of 20% liquid sodium permanganate. Sodium permanganate was applied from November 10 at 1200 hours until 1700 hours on November 11, then again from November 12 at 1200 hours until November 13 at 1200 hours.

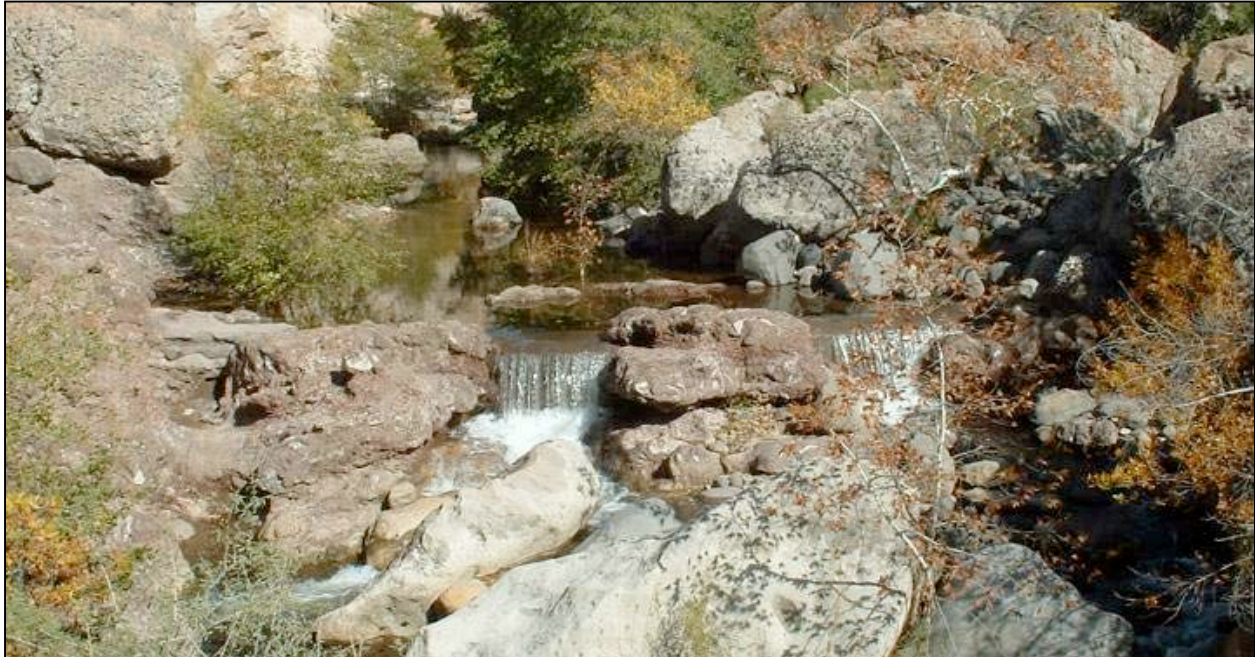
Figure 13. Fossil Creek Fish Barrier as constructed.

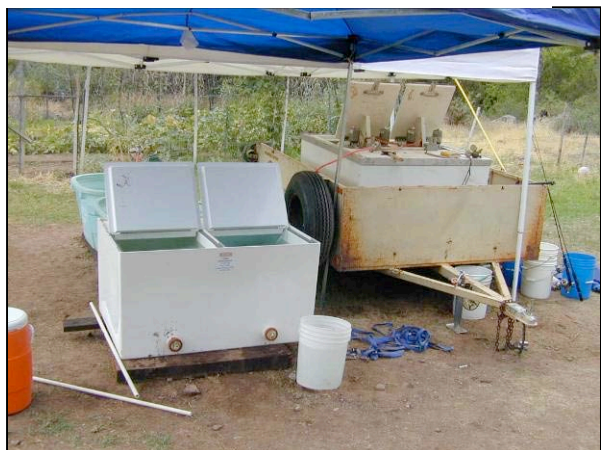
Figure 2. Smaller test tank.

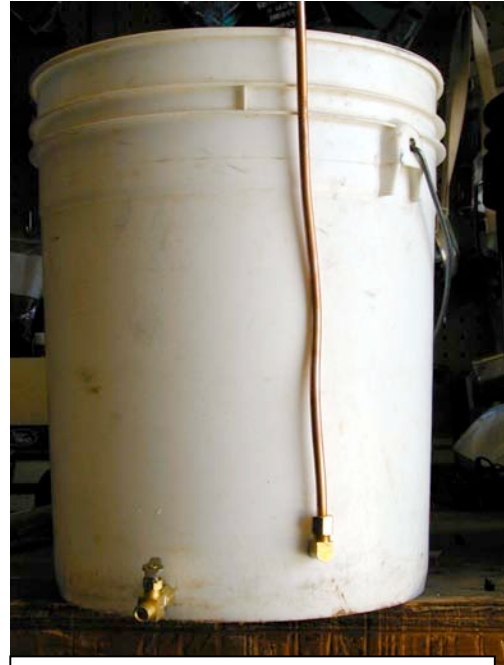
Figure 3. Assembled bucket

I used parts locally purchased at True Value for about \$15. The buckets, lids and brass fittings could likely be purchased at lower prices if bought in bulk. They did not have the needle valves, thus my need to buy a straight valve and add the adapter to extend it far enough from the bucket to allow adjustment of the valve. It would be quite simple to add an additional piece of copper tubing to the valve outflow, which came with a compression fitting, thus allowing the drip from the bucket to extend further out into the stream, likely improving mixing.
